**Flood Control Project Maintenance
Levee Inspections
LMA District Cover Sheet
Spring 2010 Levee Inspection Results**

Sutter Maintenance Yard East-West Interceptor

Spring 2010 Levee Inspection Results

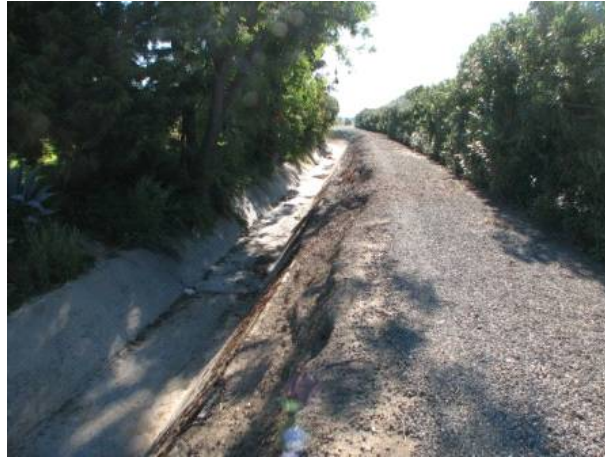
rduffey_s_20100616_053.jpg

Levee Mile Report Line	2
Start Levee Mile	0.62
End Levee Mile	0.65
Location	Land Side
Category	Earthen Levee
Item	Erosion / Bank Caving

View of the erosion along the concrete ditch on the waterside slope.

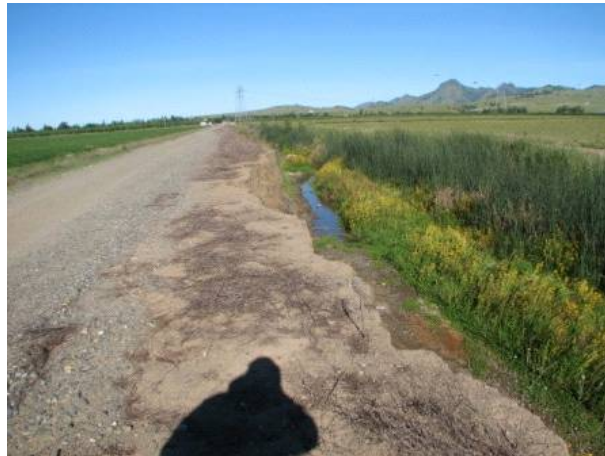
rduffey_s_20100616_054.jpg

Levee Mile Report Line	3
Start Levee Mile	1.67
End Levee Mile	1.67
Location	Land Side
Category	Earthen Levee
Item	Erosion / Bank Caving

View of the erosion along the waterside slope.

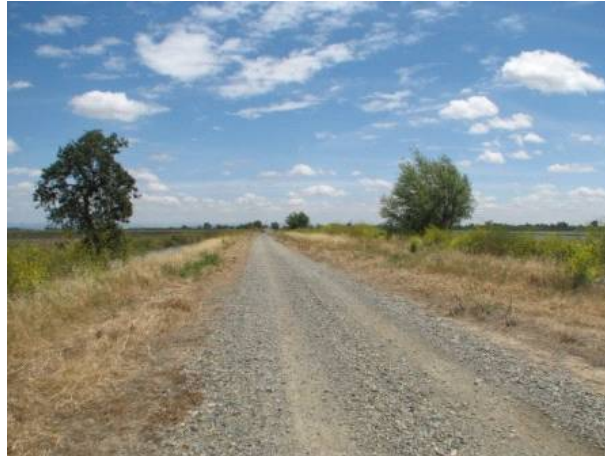
rduffey_s_20100616_056.jpg

Levee Mile Report Line	1
Start Levee Mile	0.55
End Levee Mile	1.55
Location	Land Side
Category	Earthen Levee
Item	Vegetation

View of the grasses and vegetation on both slopes.

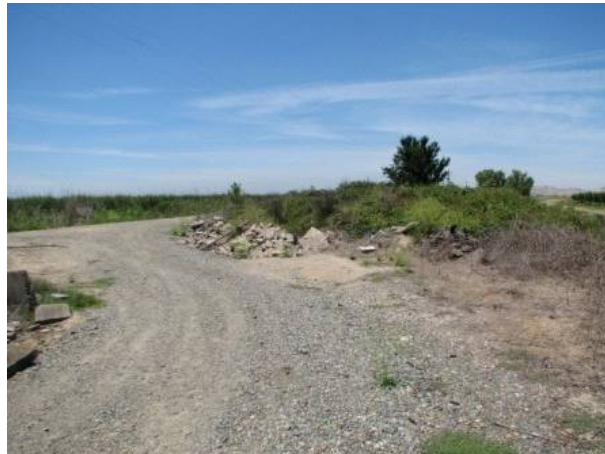
rduffey_s_20100622_075.jpg

Levee Mile Report Line	3
Start Levee Mile	1.43
End Levee Mile	1.55
Location	Land Side
Category	Earthen Levee
Item	Encroachments

View of the pile of broken concrete next to the levee.

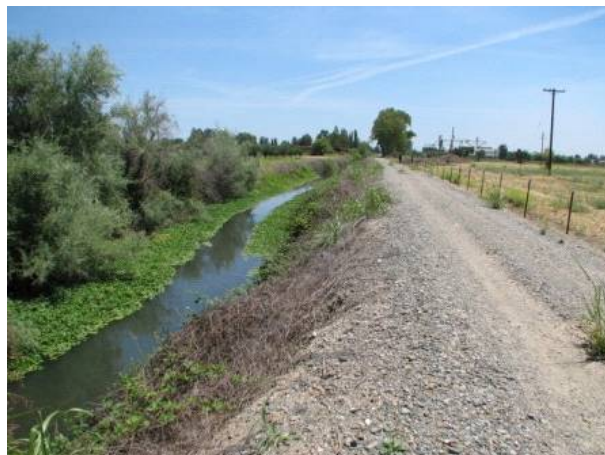
rduffey_s_20100622_076.jpg

Levee Mile Report Line	4
Start Levee Mile	1.54
End Levee Mile	1.93
Location	Water Side
Category	Earthen Levee
Item	Erosion / Bank Caving

View of the erosion along the waterside slope.

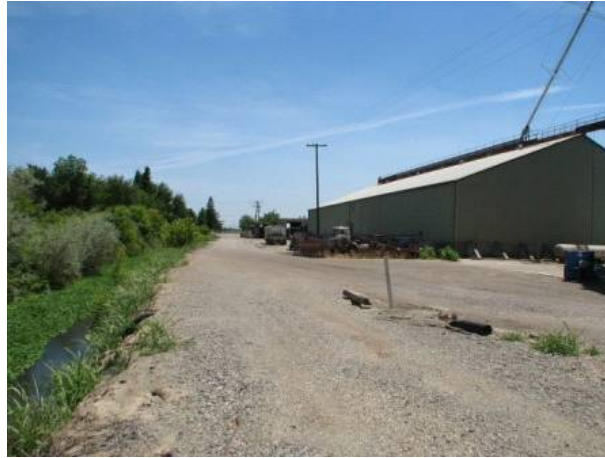
rduffey_s_20100622_077.jpg

Levee Mile Report Line	5
Start Levee Mile	1.92
End Levee Mile	2.04
Location	Land Side
Category	Earthen Levee
Item	Encroachments

View of the equipment and buildings along a landside berm.

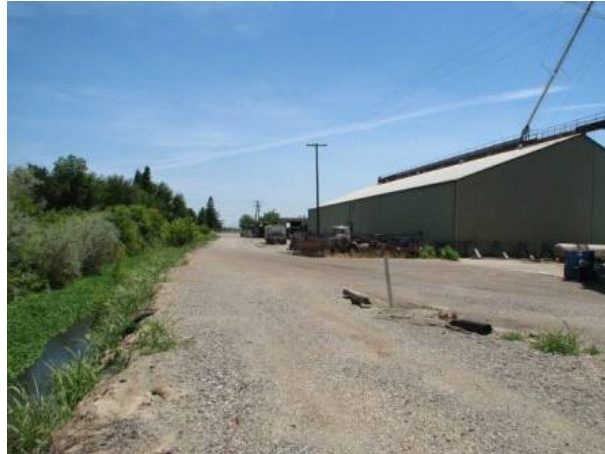
rduffey_s_20100628_098.jpg

Levee Mile Report Line	5
Start Levee Mile	1.92
End Levee Mile	2.04
Location	Land Side
Category	Earthen Levee
Item	Encroachments

View of the equipment and buildings next to the landside berm.
